A STUDY OF ROADWHEEL FAILURES MAGNITUDE - NATURE -  
CAUSES AND TESTING OF A CONCEPT TO PREVENT THEM

TECHNICAL REPORT NO. 12080

FINAL REPORT

JOHN W. CAMERON  
PROJECT ENGINEER  
USATACOM

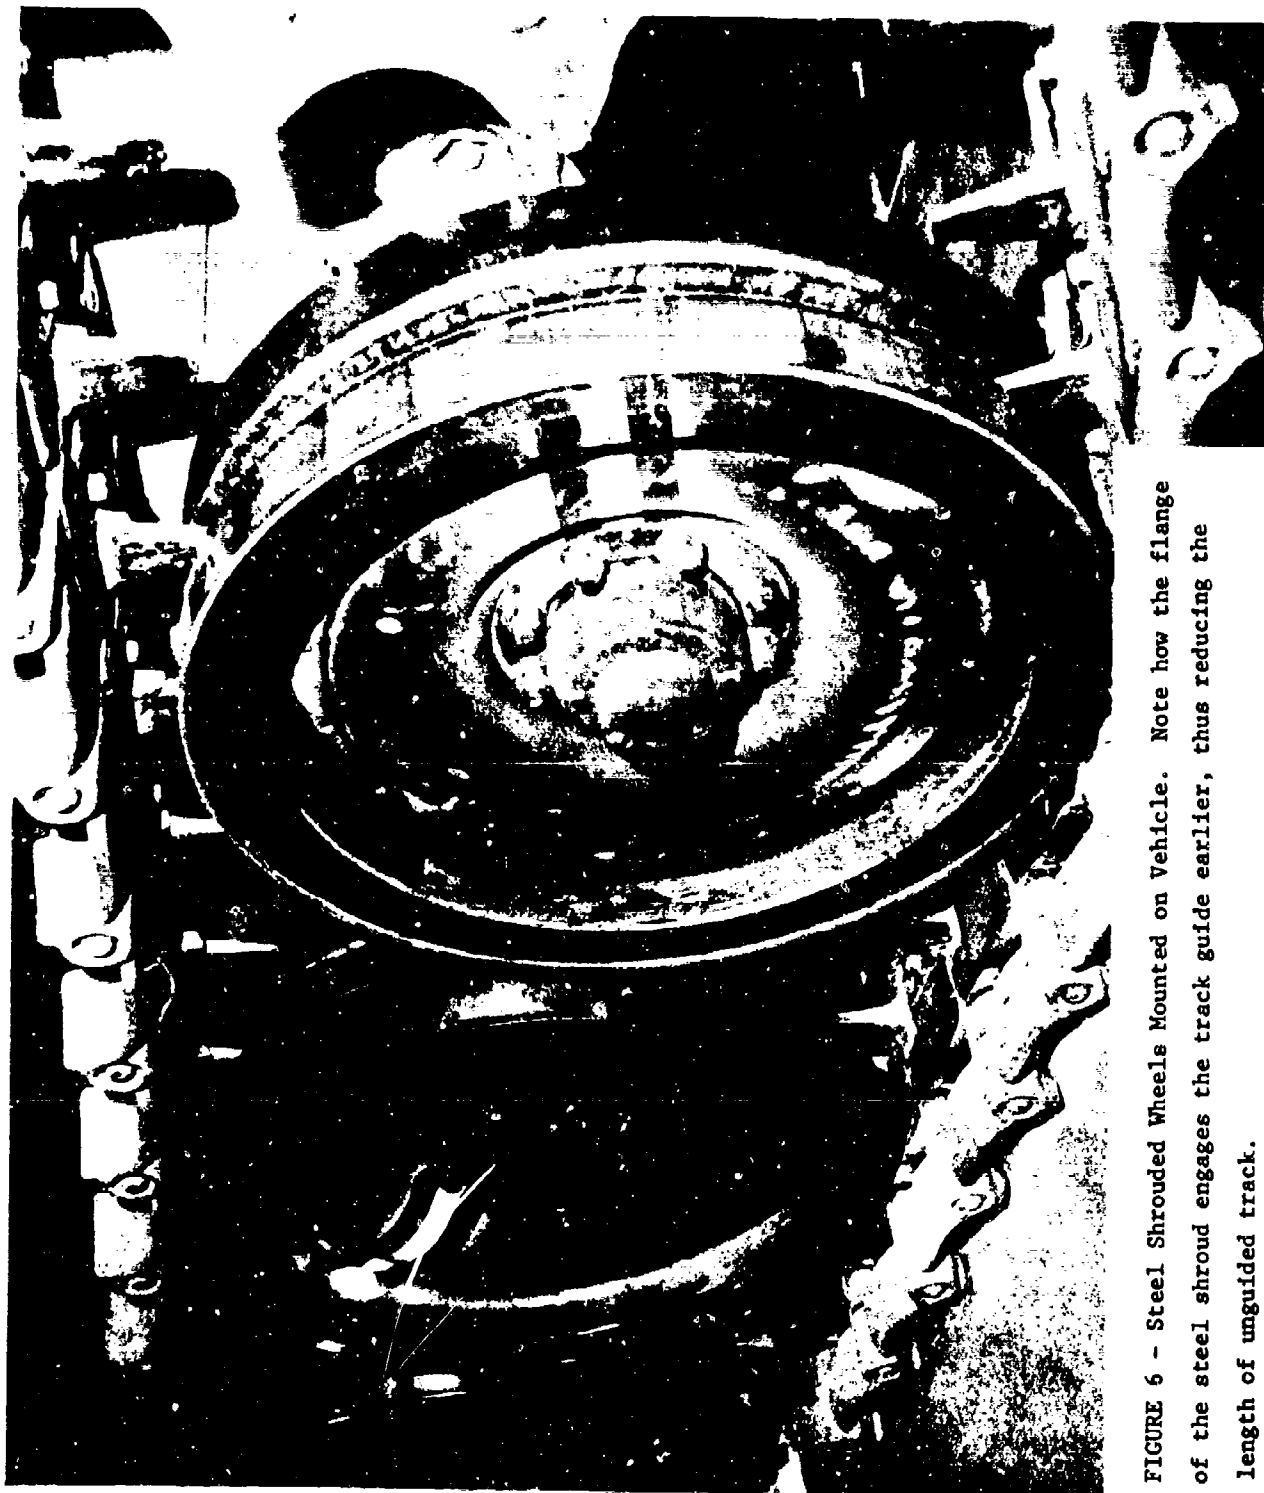
FIGURE 6 - Steel Shrouded Wheels Mounted on Vehicle. Note how the flange of the steel shroud engages the track guide earlier, thus reducing the length of unguided track.
